ULTRASONIC INSPECTION REPORT

Client	Metro Cranes	Report No	23-1065-2
Address	65 Owen St, Glendenning NSW 2761	Date of Test	17/05/2023
		Client Order N°	Not advised
Work Location	As above	Client Job N°	Not applicable
Contact Name	Robert 0435 802 722	Request N°	Not Advised

Description of Work	Ultrasonic Flaw Inspection of Terex Franna MAC25. Serial Number 25868. DOM 2013
---------------------	---

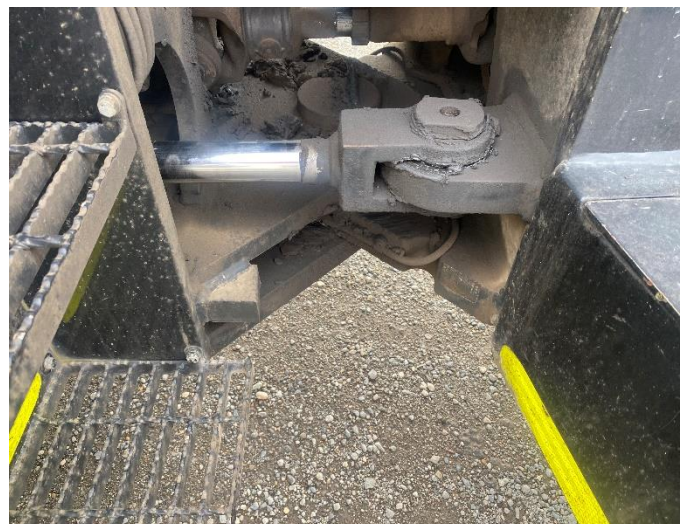
Articulation & Steer Bolt

No crack like indications were detected.
The above items comply with the requirements of the Acceptance Specification.
